RAM AIRCRAFT, L.P.  
SERVICE BULLETIN

**SB2013-02**

**SUBJECT:** One-Time Visual Inspection of Bolts – Front Engine Mount Support (aft bolts)

**MODELS AFFECTED:** Cessna 414A modified by STC # SA09105SC-D (a.k.a. RAM Series VII)

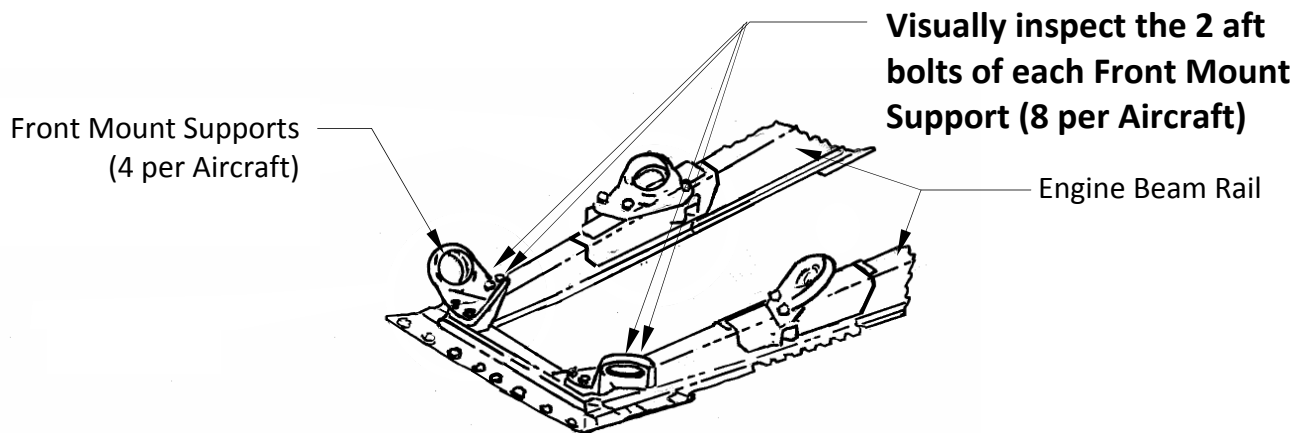
**FIGURE 1**  
Engine Nacelle Structure  
LH same as RH

2. Locate the two aft bolts on each of the Front Mount Supports (8 bolts per Aircraft) as shown in Figure 1.
3. Visually inspect each bolt for security and for proper thread engagement through corresponding nutplates, which are visible through lightening holes on each engine beam rail. See Figure 2A and 2B for location of lightening hole.

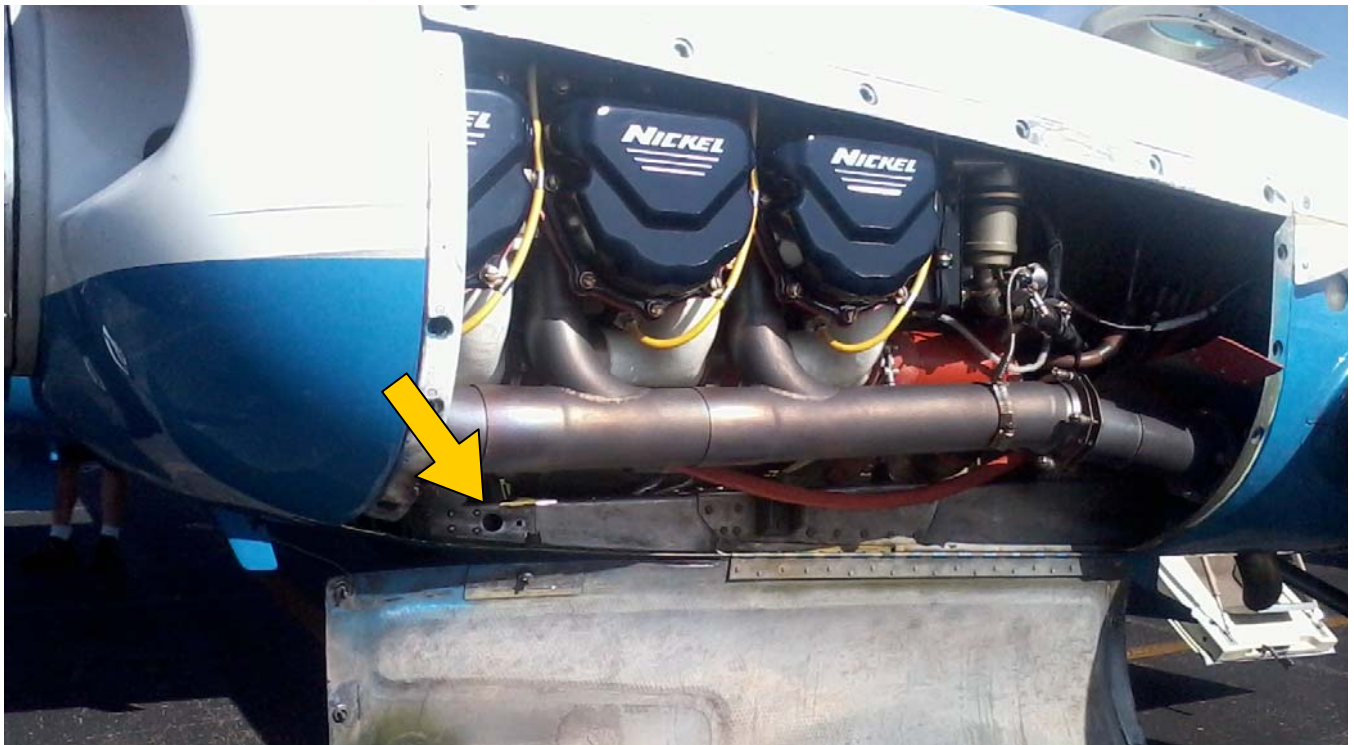
**FIGURE 2A**

**Lightening Hole**

LH Outboard Beam Rail Shown

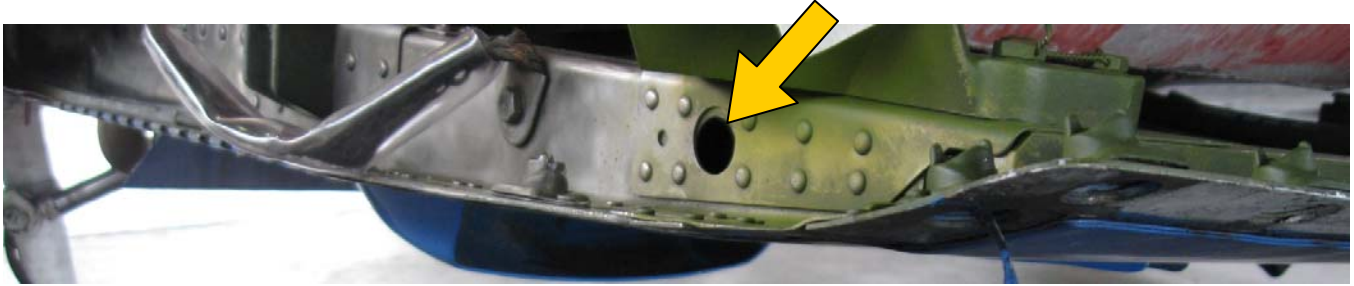
**FIGURE 2B**

**Lightening Hole**

RH Outboard Beam Rail Shown

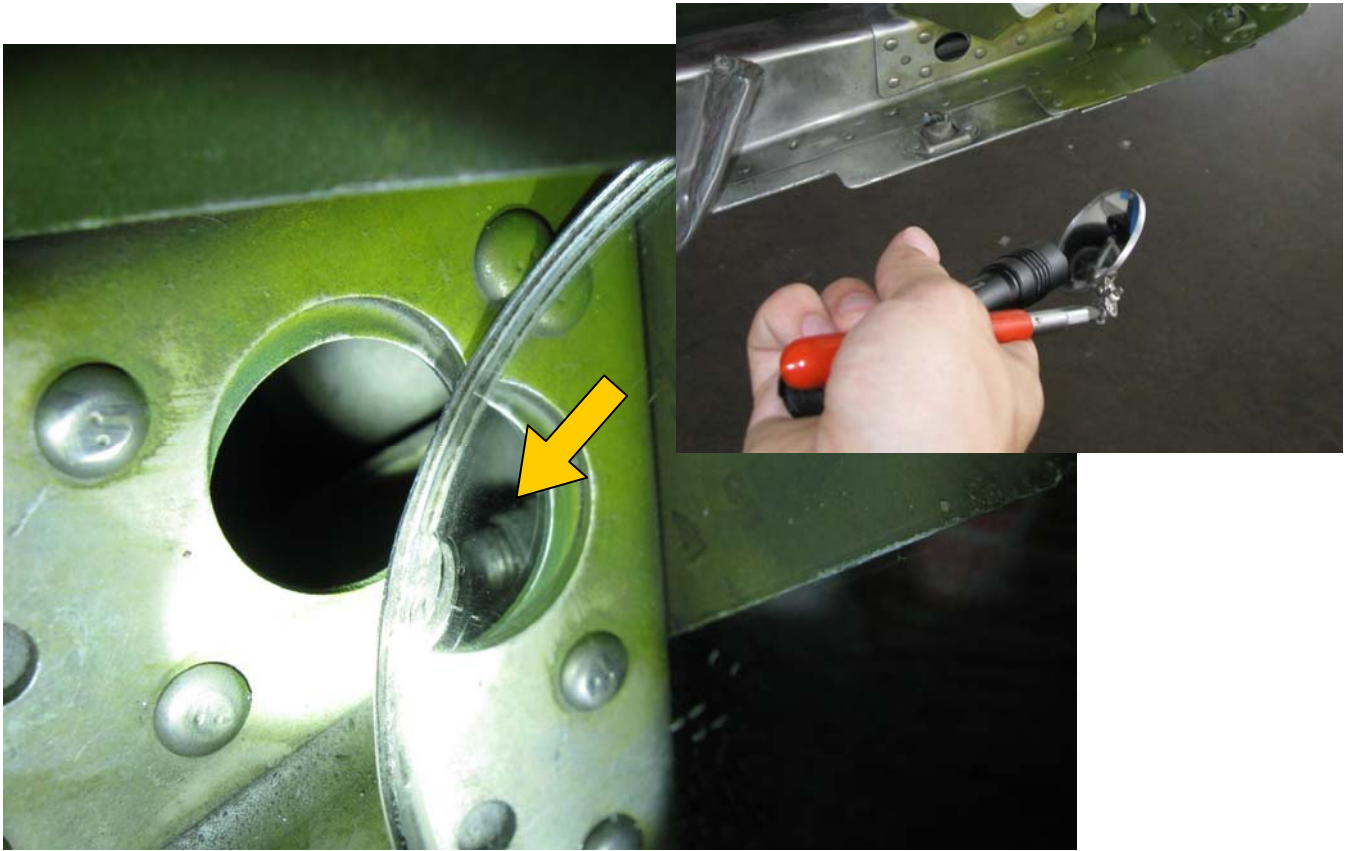
**FIGURE 3**

4. Use a borescope or a light source and inspection mirror to inspect bolt thread engagement as viewed inside the engine beam rails through the nearby lightening hole. See Figure 3. Both nutplates are visible through this hole at each beam rail.

**Nutplate viewed through lightening hole with light and mirror**

Grasp mirror and light as shown in upper RH photo.  
 Main photo view is looking aftward through lightening hole at aft nutplate/bolt threads on Front Mount Support on RH outboard Engine Nacelle

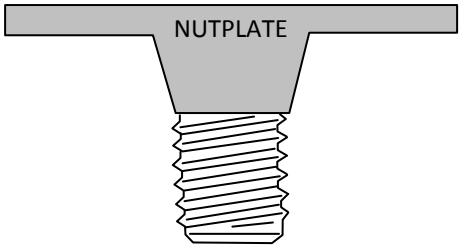
**FIGURE4**

1. As viewed in Figure 3, each of the bolts shall have a minimum of 2 threads and a maximum of 6 threads protruding past the end of the nutplate. See Figure 4.

ACCEPTABLE MINIMUM THREAD ENGAGEMENT

2 threads protruding past end of nutplate

ACCEPTABLE MAXIMUM THREAD ENGAGEMENT

6 threads protruding past end of nutplate

**Thread Protrusion through Nutplate**

1. If less than two (2) threads protrude past the end of the nutplate, remove the bolt and replace it with bolt p/n AN4H11A. Torque and safety wire bolts in accordance with Cessna 414A Service Manual instructions.
2. If a bolt is found loose or has more than six (6) threads protruding, contact RAM's Customer Service Department for parts and for further instructions.
3. Make appropriate logbook entry.
