**RAM AIRCRAFT, L.P.  
SERVICE BULLETIN**

**SB2017-02**

**SUBJECT:** Exhaust Coupling, V-Band (p/n 2177-300) – Possible Improper Spot Weld

**PURPOSE:** Recall Non-Conforming Parts

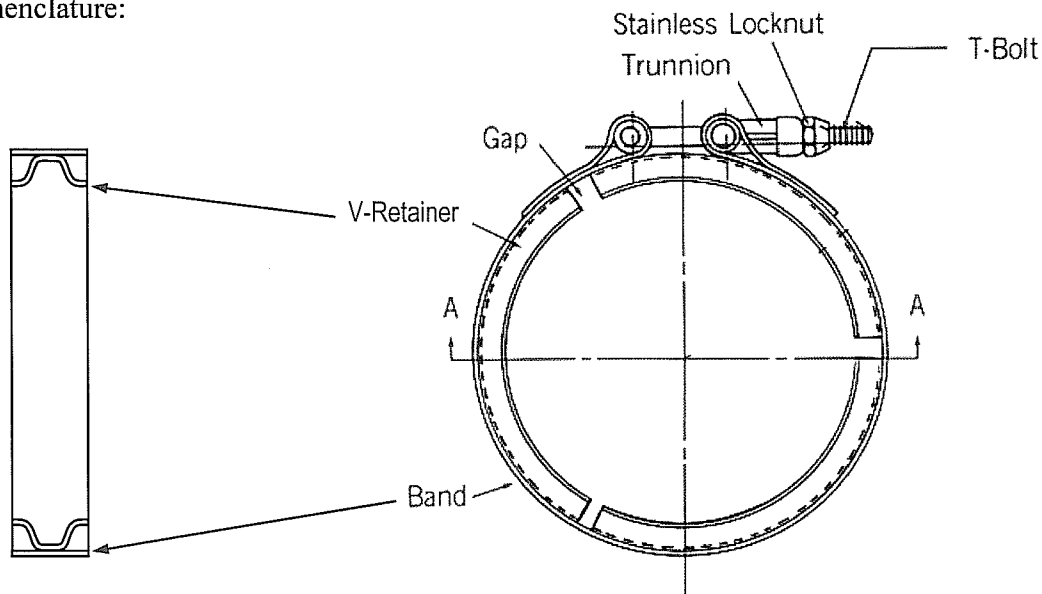
**FIGURE 1: 2177-300 V-BAND COUPLING**

3. Spot-welds not centered on v-retainer and band as shown in Figure 3 are non-conforming.
    4. Gaps not evenly spaced within circumference are non-conforming. See Figure 1.

1. Replace non-conforming v-band coupling p/n 2177-300 at next scheduled annual or 100-hour inspection (whichever occurs first).
  - a. For questions, replacement parts, and warranty considerations, contact RAM Aircraft LP (See Section E) for instructions.
2. Install replacement v-band couplings in accordance with RAM document # 2166, available online at [www.ramaircraft.com](http://www.ramaircraft.com).

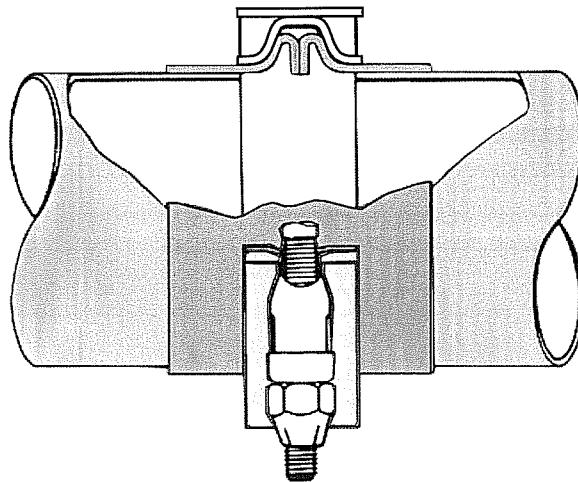
**FIGURE 2**  
**Exhaust Joint Assembly (Coupling Properly Installed)**

1. Couplings not in the proper location as shown in Figures 2 & 3 are non-conforming.
    2. V-retainers not centered in band as shown in Figure 3 are non-conforming.

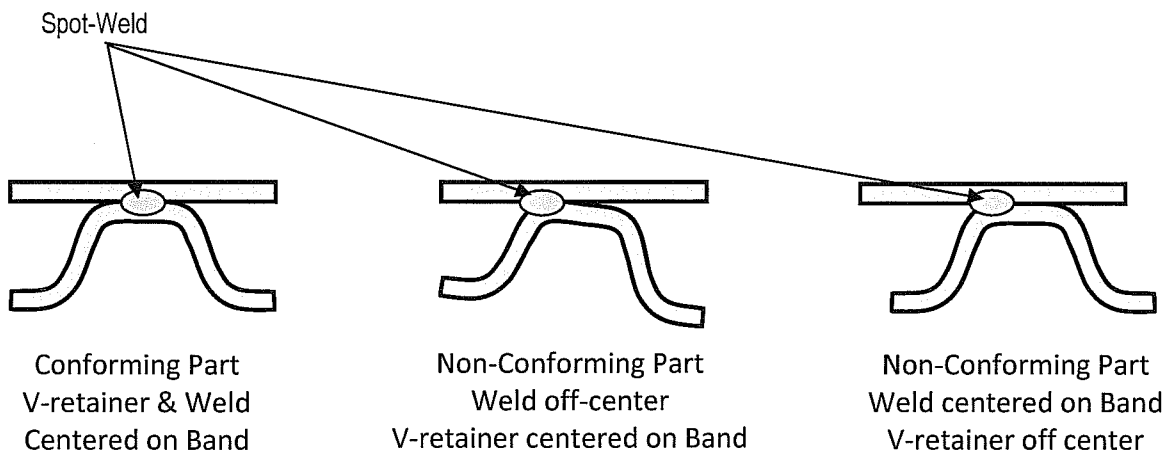
**FIGURE 3**  
**Cross-Section of V-retainer/Band (Welded Joint)**

In collaboration with our supplier, we determined that the root cause was that the resistance (spot) welder tip contacted the retainer on the radius instead of making full contact in the middle (of the v-retainer). This non-conforming condition was found to be random among the 64 couplings we removed from RAM’s stock.
