RAM AIRCRAFT, L.P.
SERVICE BULLETIN

SB2019-01

SUBJECT: Hardware installation at upper forward-most bolt boss on RAM FAA-PMA crankcases

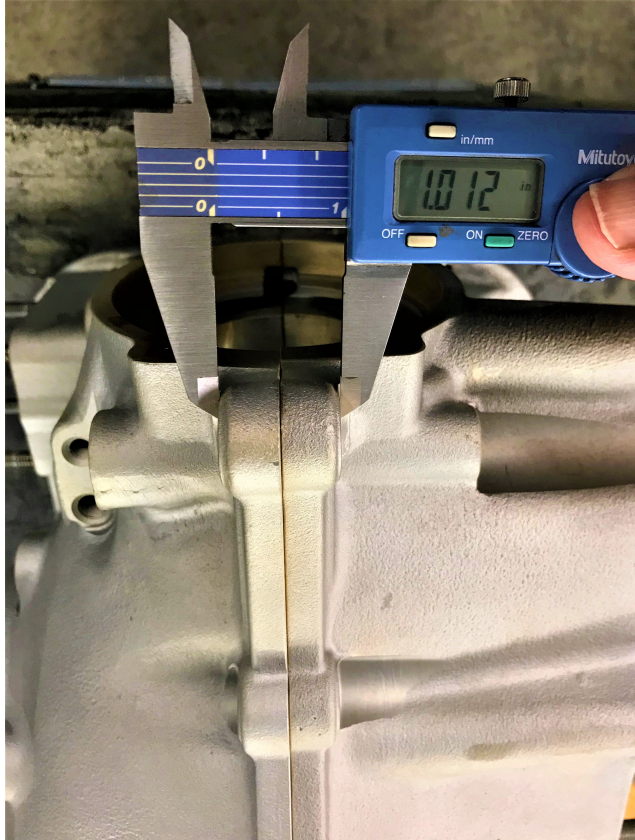
STANDARD MEASUREMENT (APPROX 1.00)

Inspect left and right crankcase mating halves at upper-forward-most bolt boss. With crankcase halves mated together, measure across both halves at the bolt boss. The boss material thickness should be generally 1.0 inches. Each half should have equivalent thickness (approximately 0.5 inch each half). Mis-machined bosses will be evident as the overall total width is approximately 0.85 inches in lieu of the standard 1.00-inch width. See Figure 3.

If total measurement across the Left and Right halves measures 1.00 inches (+/- .05 inch) no further action is required. Use standard hardware as specified in the applicable service manual or overhaul manual.

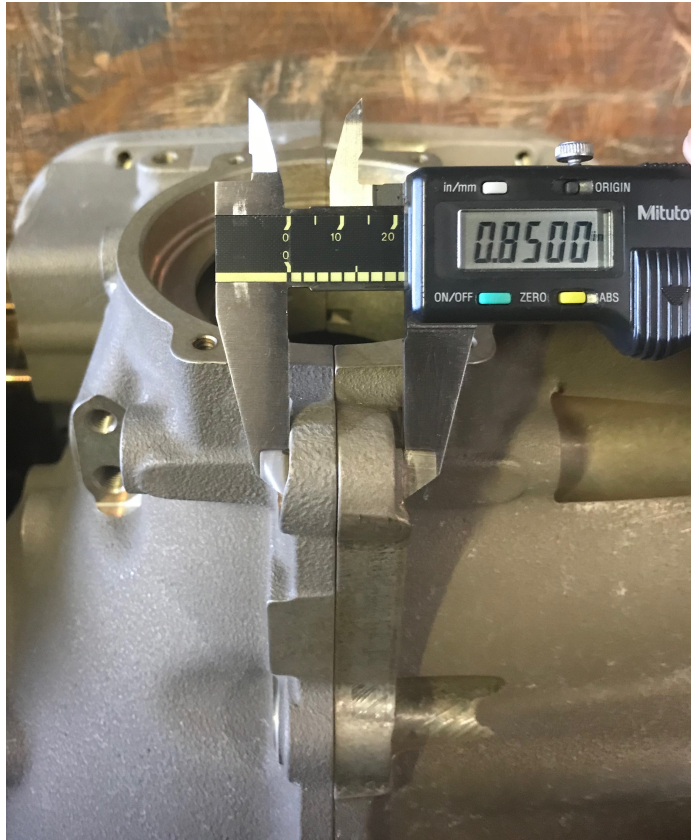
MIS-MACHINED MEASUREMENT (APPROX 0.85)

If total measurement is less than 0.95 inches, refer to Section “D” for corrective action.

1. For affected engines installed without electro-thermal propeller de-ice systems, the bolt installed in the upper forward-most bolt boss (See figure 1), will need to be shorter than the standard bolt. Use bolt part number AN5-11A in lieu of the specified AN5-13A bolt in this location only. Alternatively, it is acceptable to use AN5-12A bolt with no more than two extra p/n AN960-516 washers to ensure that the nut may be properly tightened to required torque value with no possibility of bottoming on the bolt shank.
2. For affected engines installed with electro-thermal propeller de-ice brush block bracket assembly, it is acceptable to install a stack-up of washers (or a combination of washers and the standard spacer) between the crankcase boss and the bracket. Select the number of washers, p/n AN960-516 or AN960-516L as required to fill the space.
