RAM AIRCRAFT, L.P.
SERVICE BULLETIN

SB2019-01

SUBJECT: Hardware installation at upper forward-most bolt boss on RAM FAA-PMA crankcases

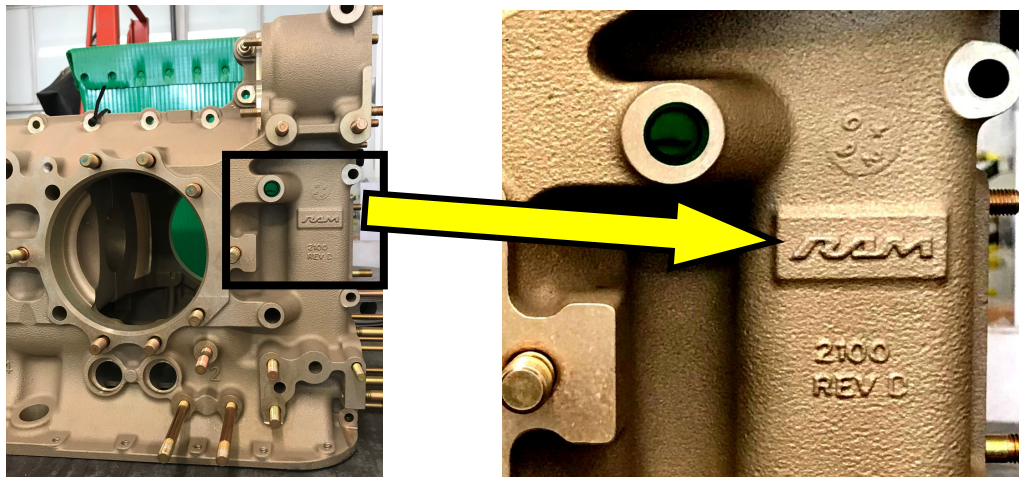
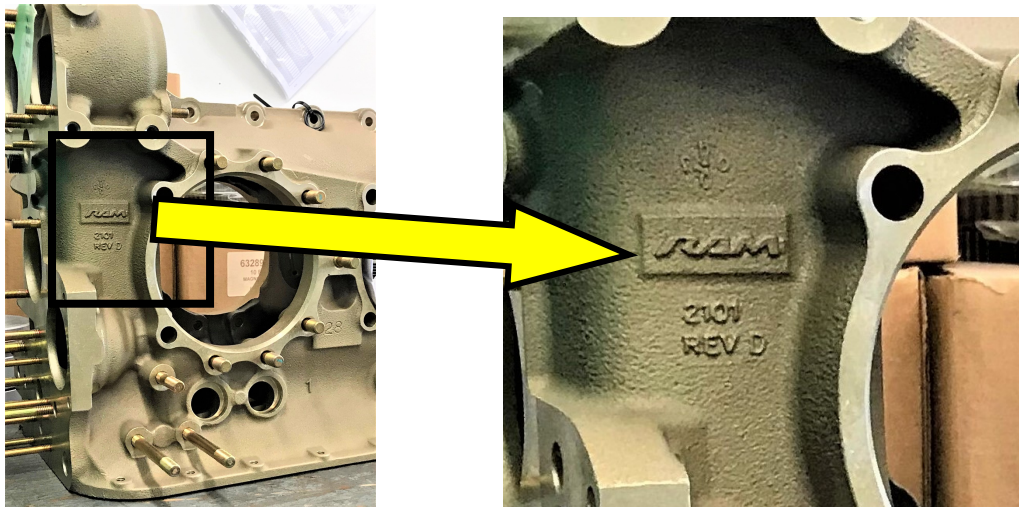
FIGURE 1
RAM FAA-PMA Crankcase Identification

Identify RAM FAA-PMA crankcase by looking for the RAM logo embossed at the rear of the crankcase as shown in Figure 1. Identify RAM part number and serial number stamped at lower-most flange at nose end of crankcase as shown in Figure 2.

1. For affected engines installed without electro-thermal propeller de-ice systems, the bolt installed in the upper forward-most bolt boss (See figure 1), will need to be shorter than the standard bolt. Use bolt part number AN5-11A in lieu of the specified AN5-13A bolt in this location only. Alternatively, it is acceptable to use AN5-12A bolt with no more than two extra p/n AN960-516 washers to ensure that the nut may be properly tightened to required torque value with no possibility of bottoming on the bolt shank.
2. For affected engines installed with electro-thermal propeller de-ice brush block bracket assembly, it is acceptable to install a stack-up of washers (or a combination of washers and the standard spacer) between the crankcase boss and the bracket. Select the number of washers, p/n AN960-516 or AN960-516L as required to fill the space.

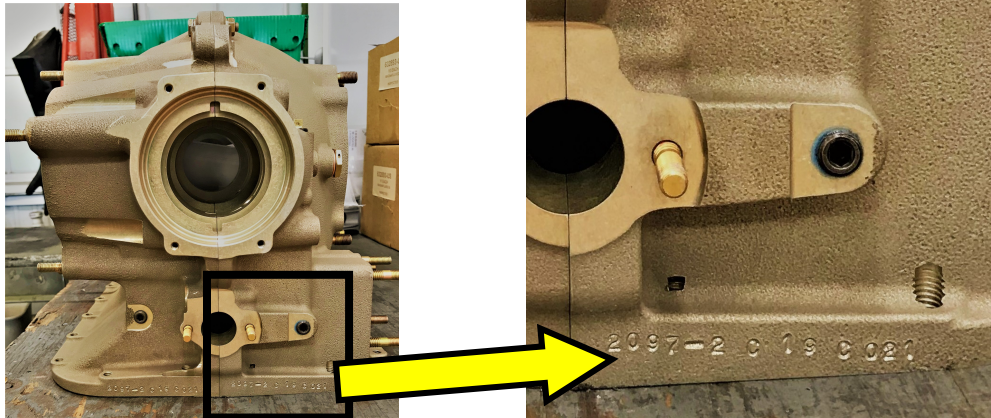
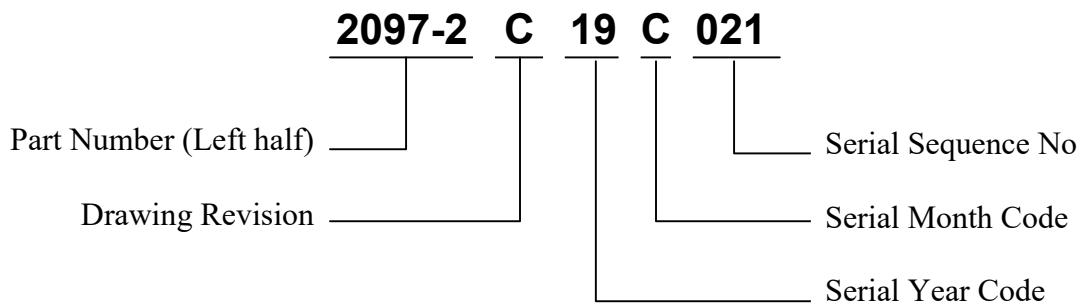
FIGURE 2
Part Number and Serial Number Identification

The Left crankcase half part number and serial number are metal stamped on the lower flange beneath the cam bore at crankcase nose as shown.
